Wear evaluation of elements of V-belt transmission with the application of optical microscope

Abstract. The paper presents the analysis of reasons, form and wear of elements of V-belt transmission. Syndromes of loss of driving properties for chosen wheels and V-belts are specified. Methodology of failure evaluation of wheels and V-belts with the application of optical microscope is proposed. The applied measuring set allows for universal analysis of the measurement results. Operation principle of this device and its measuring and analysing abilities are shown. Failures of chosen V-belts and the influence of these failures on accuracy of kinematic features of chosen driving units are evaluated.

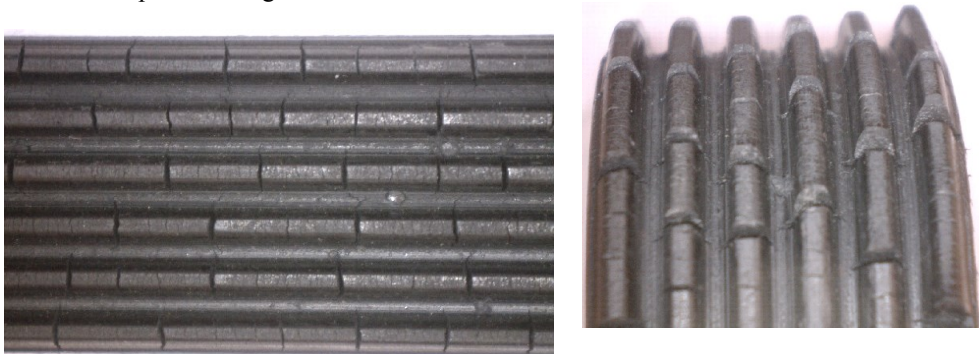
– Cracking of ribs. On the working surface of belt transversal cracks are visible, alongside one or more ribs (fig. 3). This damage is probably caused by the influence of too high or too low temperatures. Other reason of such failure may be the interaction between the belt and pulley. It is especially important when the pulley diameter is small. If the interaction is incorrect it may cause tensions which lead to cracks. The cracks appear on the top of the rib and then deepen reaching down to the cord.

Fig. 3. Multi-groove belt transversal cracks

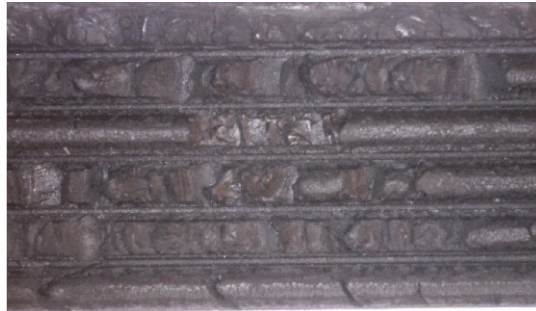
– Belt rubber flaking. When rubber flakes (fig. 4) then the belt may break immediately. Such state of the belt may be the result of many cracks cumulating in one place which are parallel to the cord strand. Such state of belt is caused by high temperature, the duration of using the belt and belt tensions.

Fig. 4. Rubber flaking in multi-groove belt

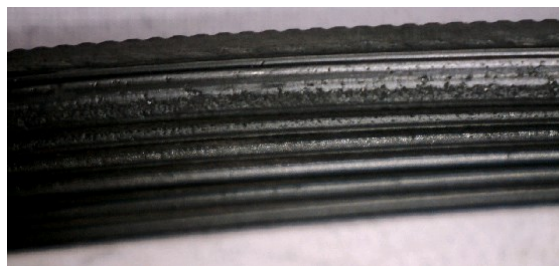
– The phenomenon of peeling. Peeling occurs (fig. 5) when the material of the belt is rubbed off the tops of the ribs and accumulates in its grooves. One of the reasons of such situation may be the improper tension of the belt, assembly mistakes or the wear of pulleys. This phenomenon is common for the belt drives of engines propelled by petrol or diesel oil.

Fig. 5. Peeling phenomenon on multi-groove Belt

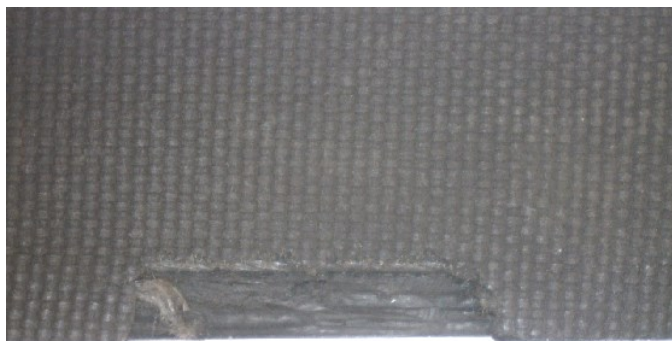
– Friction wear. The symptom of friction wear (fig. 6) is a shiny outer surface of the belt. If there is a severe wear of the belt then on its surface a piece of fabric may be visible. This state of wear may be caused by a direct interaction of the belt with an object on its way such as a flange or a screw. Other reason of appearing the friction wear may be the incorrect tension of the belt.

Fig. 6. The friction wear of multi-groove belt

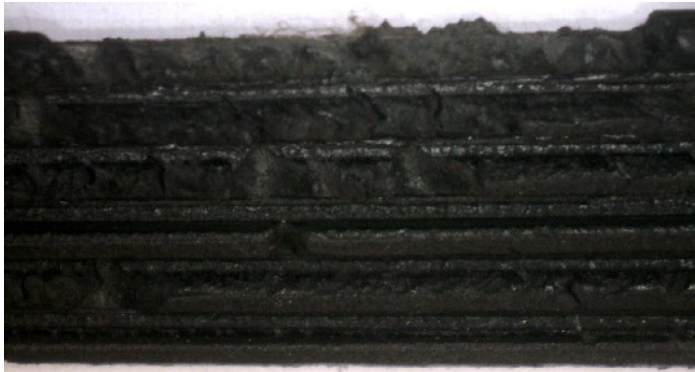
– The damage of the external belt ribs. The symptoms of such state of belt (fig. 7) appear on its sidewalls. The flat surface of the tie becomes shiny or in the most extreme cases the cord on the sidewalls is ragged. The outermost belt ribs may be rubbed off or torn off. The symptom of such failure may be the noise generated by the transmission. Such a result may be caused by the misalignment of belt pulleys.

The other symptom of such failure is bending or twisting of the belt Chile transmission works.

Fig. 7. The damage of the external belt ribs

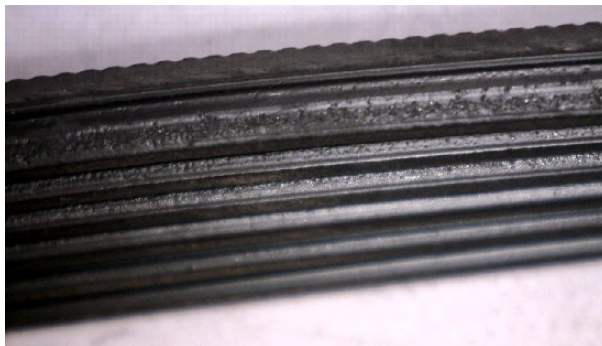
– The uneven wear of the belt ribs. This kind of wear (fig. 8) is indicated by the damage of the sides of the tie, usually in a form of broken cord or ragged belt ribs. Other indicator of this state of belt is a rumbling or scraping sound in the transmission. The cause of this form of damage may be a foreign matter i.e. a small stone on the pulley. If nothing is done when these symptoms occur then it may result in the uneven wear of the belt, cutting the material of the belt ribs to the cord and eventually lead to its breaking.

Fig. 8. The uneven wear of the belt ribs

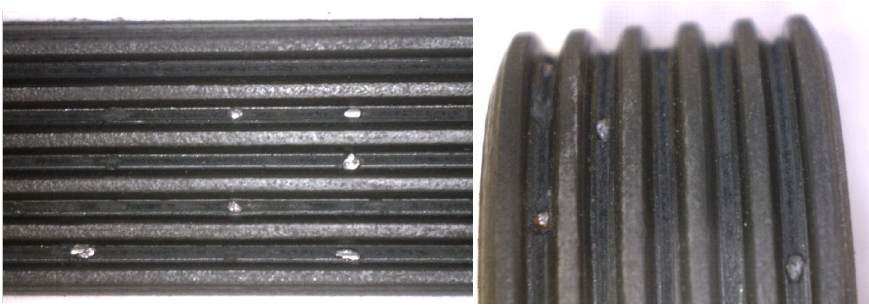
– The influence of contaminations. When on the outer (smooth) surface appear small punctures or swellings (fig. 9) and what is more, the fabric around the holes is ragged it may suggests that some contaminations penetrate into the belt. The cause of this form of damage is most often the situation when small stones, sand or gravel penetrate into the belt grooves and pulley grooves. Poly – V belts are produced with different shapes of belt ribs, some of them have sharp tops, others rounded and another ones cut off, as a result the interaction with pulleys differs so the specks of metal are the effect of the pulley rubbing off.

Fig. 9. The influence of contaminations on poly-v belt

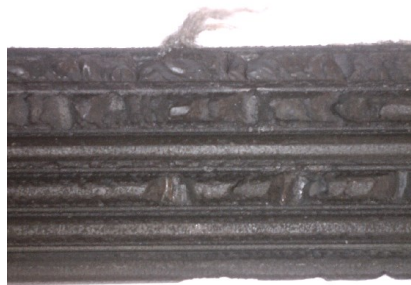
– The band separation. This problem occurs when the outmost belt ribs start separating from the rest of the material (fig. 10). When this process lasts longer then the whole rib separates and causes the damage to the fabric and another belt ribs. The reason of such state of the belt is the improper assembly of the transmission. Due to the improper assembly one or more belt ribs is beyond the groove on the pulley what causes lack of correlation of belt sidewalls that lowers significantly the duration of proper transmission work.

Fig. 10. The band separation

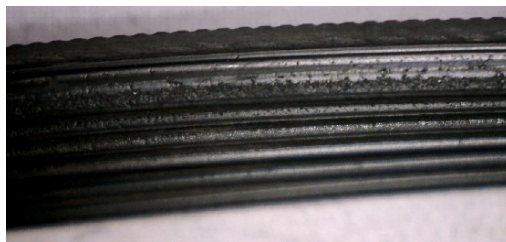
– Contamination by fluids. The surface of the belt is flaking, sticky or swollen (fig. 11). This state of belt may be caused by oil, grease or chemical substances. These substances weaken significantly the internal structure of the belt, influencing its stiffness. The belt starts slipping on the surfaces of the pulleys. Inseparable symptom of this state is the increase of the belt temperature.

Fig. 11. Fluid contamination in poly-v belts

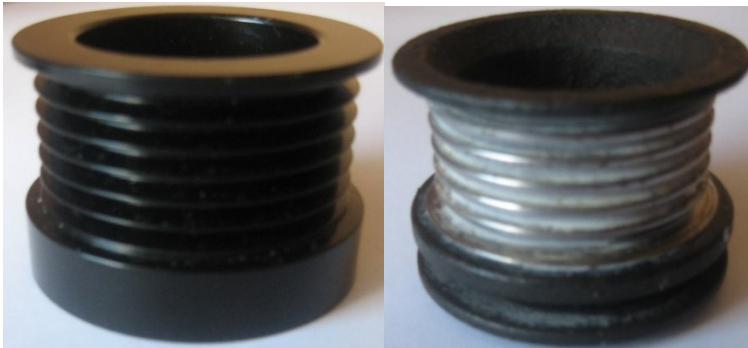
Fig. 12. New pulley and pulley exploited for about 250000 km

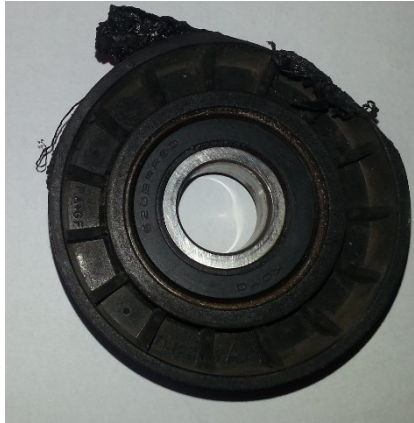
Fig. 13. The sample failure of multi-groove pulley tensioners

The most common reasons of multi-groove pulley tensioner failures (fig. 13) are:

- rusty dripstones and cracks. Rusty liquid flows between tensioner arm and base or it drips from the tensioner. Rust leaks are the symptoms of internal wear of a part. Most of these types of failure occur where the limiters and tensioner mounting screws are.
