Structural changes of selected materials for glass industry after thermal loading

Abstract. The presented paper is focused on study and investigation of structural changes in relation to the selected materials which are exposed to the thermal loading. The given work is connected with closer investigation of such material as Dominial ZF 2 which is commonly used for production of steel moulds and components in the glass industry. Moreover, the given work is also devoted to the investigation of materials which are commercially called Toolox 33 and Toolox 44 because these materials were proposed by firm to be used as substitutive materials of Dominial ZF 2. Both of the mentioned and investigated materials have not been used in glass industry yet. Experimental procedures were proposed on the basis of the fact that the investigated materials are exposed to thermal as well as mechanical loading and they are in direct interaction with hot molten glass. After simulated thermal loading, the investigated materials were exposed to the static tensile test and by this way, it was possible to obtain samples with fracture surfaces and these fracture surfaces were evaluated in terms of characteris

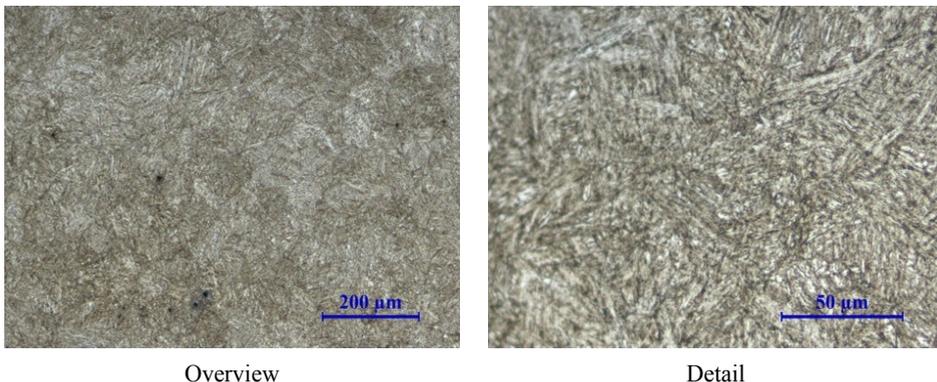
Fig. 1. Microstructure of the as delivered Toolox 33 material – uncycled

The microscopic examination of the delivered materials showed that both proposed steels had a structure consisting of lower bainite, respectively of sorbite with local occurrence of martensitic needles and residual austenite (Fig. 1, Fig. 4). The microstructure of the Dominial ZF2 steel is austenitic with the occurrence of fine carbides along the grain boundaries (Fig. 7).

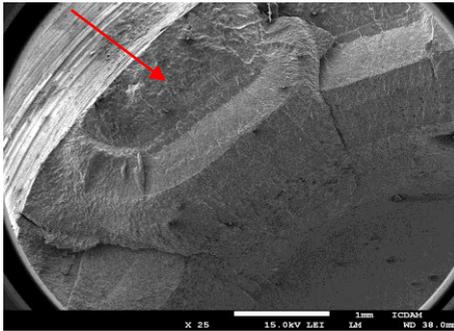
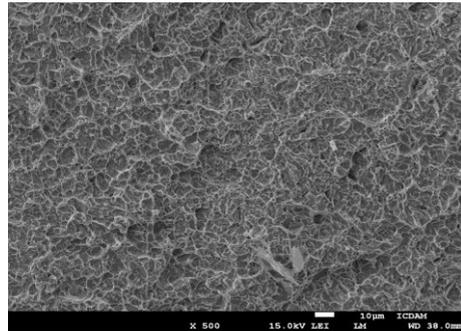
Fig. 3. Fracture surface of Toolox 33 after 50 cycles

On metallographically prepared sections (Fig. 2) of the area under the fracture surface (after the heat load cycles), structural changes that characterized the fatigue process around the crack were observed. In this area, there occurred strain-stress state, which subsequently resulted in a failure. The fracture surface shows the defined locations in the structure, which are typical for the coexistence of individual phases with different ductile and strength characteristics (Fig. 3). These areas support the local concentration of microdeformation processes leading at different sites to cohesion failure (the red arrow indicates the site of initiation and the occurrence of secondary cracks).

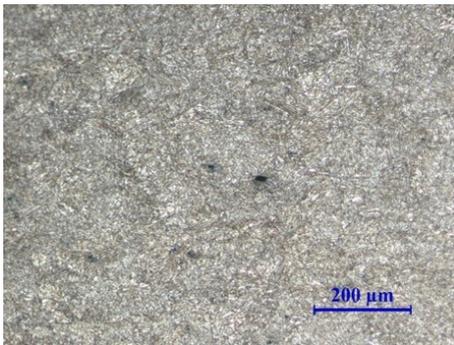
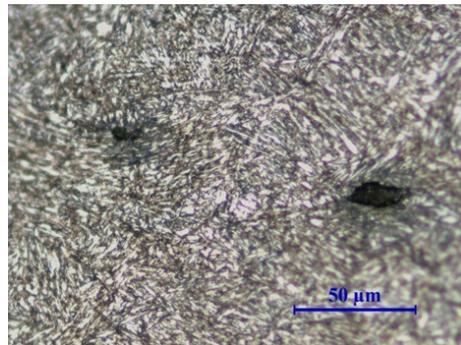
Fig. 4. Microstructure of the as delivered Toolox 44 material – uncycled

Toolox 44 has a similar microstructure (Fig.4) as Toolox 33 including the occurrence of inclusions formed due to chemical heterogeneity of the material.

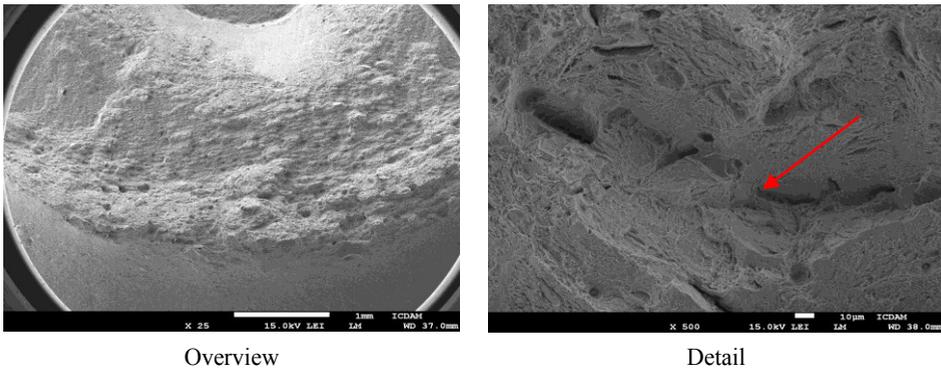
Fig. 6. Fracture surface - Toolox 44, after 50 cycles

In the given case, it is a failure of the mixed nature, where ductile and fragile locations alternate in the fracture surface depending on the character of phases present in the structure (Fig. 6). The arrow point at the initiation sites of the failures.

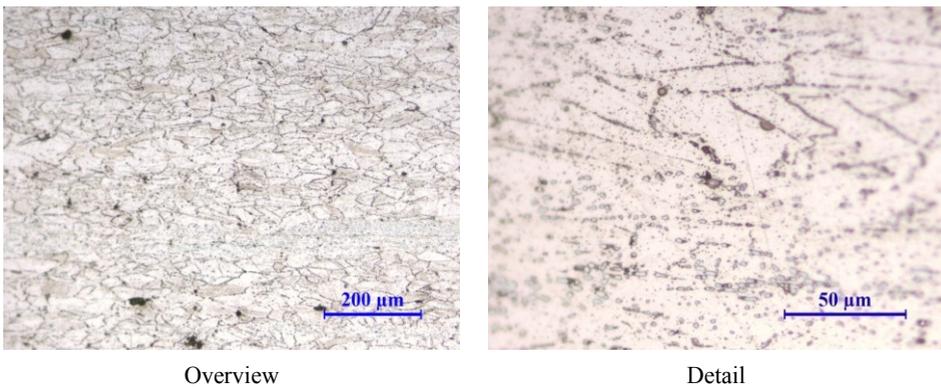
Fig. 7. Microstructure of the base material - Dominial ZF – uncycled

Dominial ZF2 steel is heterogeneous depending on size of austenitic grains (Fig. 7), which react to changes of deformation effects (after 50 heat load cycles) in different ways. There occurs a texture, which cease to exist in proximity of the fracture surface (Fig. 8).

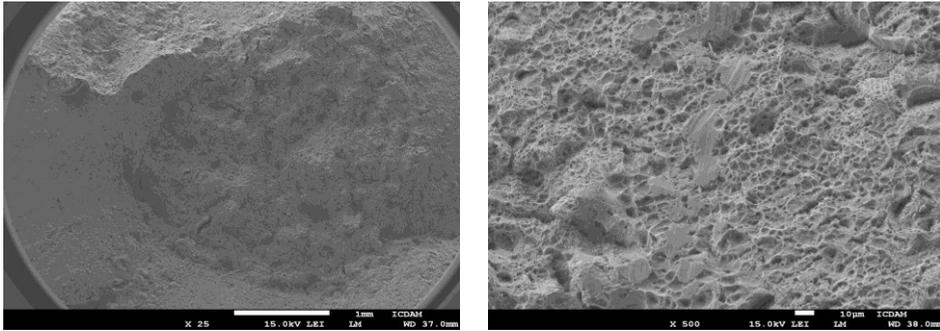
Fig. 9. Fracture surface - Dominial ZF 2 – after 50 cycles

Here, it is possible to mark the failure of the Dominial ZF 2 steel as ductile with the different size of the dimples on the edge of the sample and in its core (Fig. 9).

Based on these findings, it can be stated that the evaluated steels, which are supposed to replace the materials currently used, will be very sensitive to temperature changes. There is a risk of uncontrollable processes in materials initiated by thermal-mechanical load. This will further lead to a greater reduction of the service life of components made of this material. That is the reason why Toolox 33 and 44 steels are not recommended for the production of glass molds.
