The experimental measurement of the tyre casing defects for the freight vehicles at the dynamic loading

Abstract. The paper deals with the experimental measurement of the tyre casing defects for the freight vehicles at the dynamic loading. The given investigation was mainly focused on cracks and defects in tyre casing, which is commonly used for freight vehicles. The mentioned measurement or investigation was performed under the strictly specified conditions. The given measurement of crack propagation in car tyre casing was based on changes of speed, changes of loading as well as changes of service time interval. It is important to point out that the pressure in the tyre was predetermined to be the constant value. The experimental procedures were carried out by help of special drum testing machine with designation: IGTT 25 kN – C and with the 1707 mm drum diameter. The mentioned measurement was performed for the area of tyre casing shoulder and it was in the site between the first and the second buffer lining. Using the ITT- 1 program relating to non-destructive testing analyser, the CCD camera for testing procedure of tyre casing was used for the camera images which were taken fr

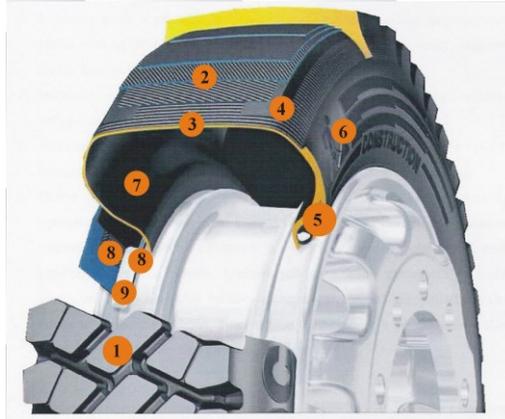
Fig. 1. Structure of tyre casing: 1) Tread; 2) Buffer linings; 3) Cord carcass; 4) Filling linings; 5) Bead bundle; 6) Sidewall; 7) Inner skim rubber; 8) Bead reinforcement; 9) Bead plies

The Fig. 1 shows the given parts mentioned hereinbefore.

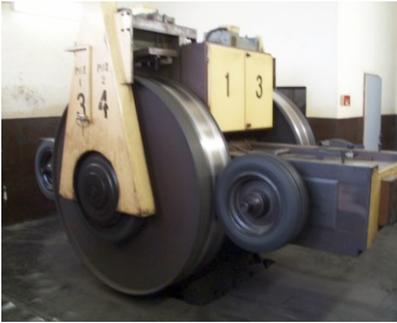
Fig. 2. Drum testing device

The distribution of separations was investigated by help of special drum testing device IGTT 25 kN – C where the diameter of drum was 1707 mm (Fig.2) and by help of non-destructive analyser see (Fig. 3).

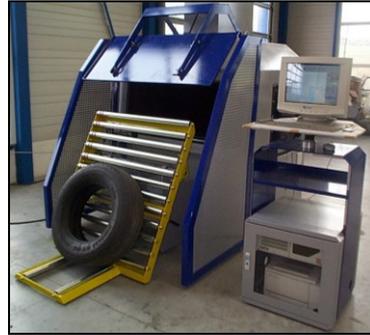
Fig. 3. Non-destructive analyser

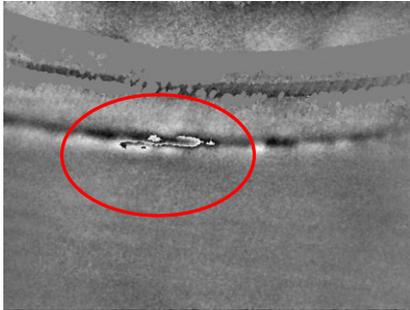
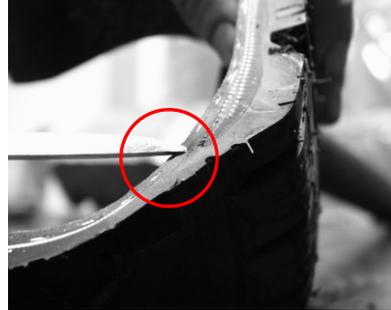
Fig. 11. The local separation in the shoulder where the first buffer lining ends

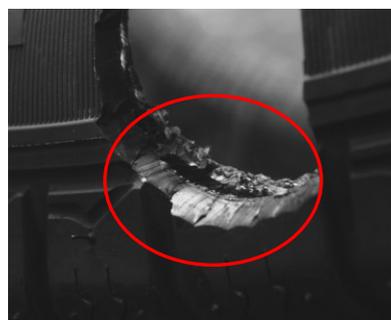
Fig. 13. The longitudinal separation in the shoulder and its expansion to the side directions

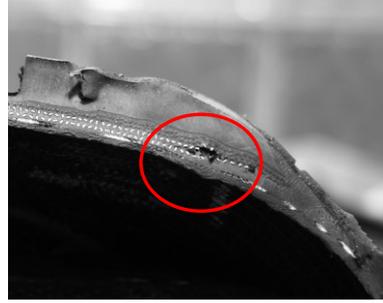
Fig. 14. The local separations in the shoulder in the site where the second buffer lining ends
